Evolution of Surface Texture and Cracks During Injection Molding of Fiber-Reinforced, Additively-Manufactured, Injection Molding Inserts

Hofstätter, Thomas; Mischkot, Michael; Pedersen, David Bue; Tosello, Guido; Hansen, Hans Nørgaard

Published in:
Proceedings of ASPE Summer Topical Meeting 2016

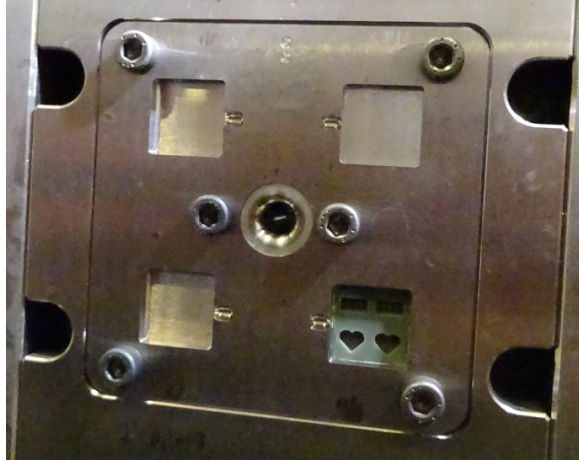
FIGURE 1. Single insert in the IM machine before the first shot.

The additively-manufactured insert was built into a multi-functional frame in the IM machine as shown in Figure 1. The LD-PE was injected from

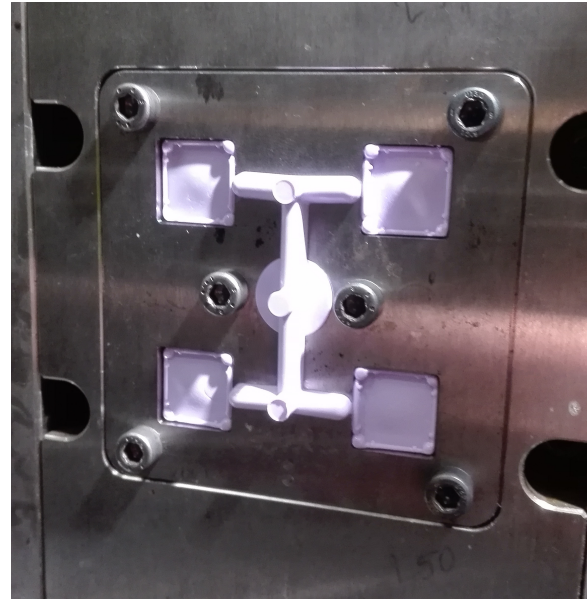
FIGURE 2. PE-LD parts arranged in the IM machine.

the reverse side of the insert and through channels guided to the mold. The final part before ejection can be seen in Figure 2.

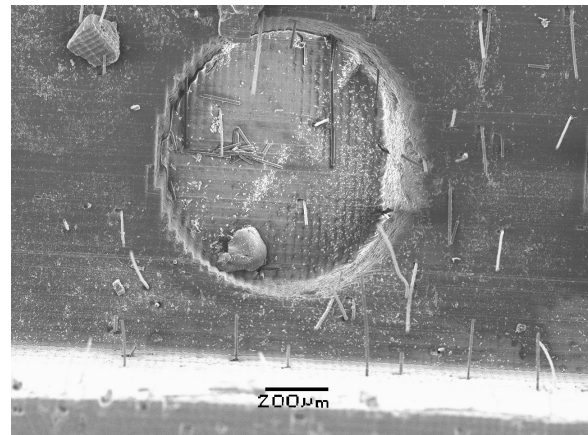
FIGURE 3. Fibers standing out of the produced layers in a SEM investigation confirming the findings in [9]. The image was taken before the first shot. The raster pattern on the surface results from the DLP process and the projector resolution.

During this investigation, the observations in [9] concerning outstanding carbon-fibers at the border of the object were confirmed as the first manufactured parts showed residual carbon fiber material in the upper layer of the part. The outstanding fibers broke off after the first shot and stuck to the produced part. No residuals were found at the second shot and later. The outstanding fibers in the original IM insert are shown in Figure 3. It shall be noted that no fibers are standing perpendicular to the top surface layer.

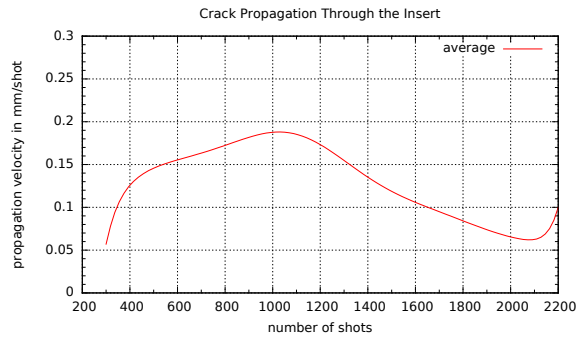
FIGURE 4. Crack propagation velocity over the number of shots (averaged).

The crack propagation had an average velocity of 0.145(34) mm/shot after the first sign of the crack until the failure of the part. Figure 4 shows the averaged crack propagation velocity over time showing an increase of the velocity up to 0.19 mm/shot followed by a decrease until failure of the insert. The crack propagation is visualized in Figure 5 to Figure 8 showing the first cracks at shot 500. Crack 2 is blocked by crack 1 after shot 1300 and therefore does not propagate any further. Note also the degradation of the edges as can especially be seen in the round parts on the left side of the figures. Crack 3 also propagates on another level on the lower part after shot 1300.

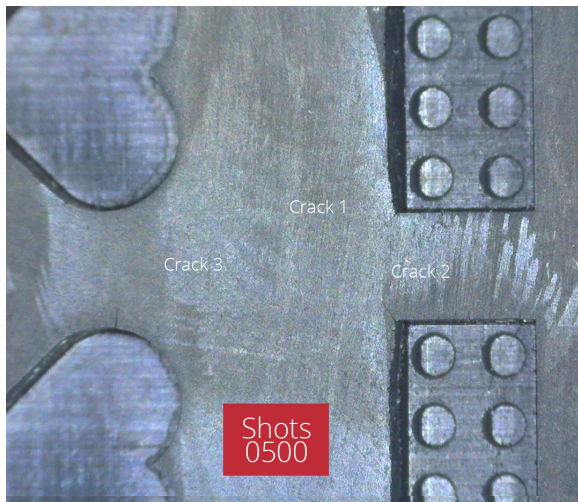
FIGURE 5. Cracks in the insert after shot 500.

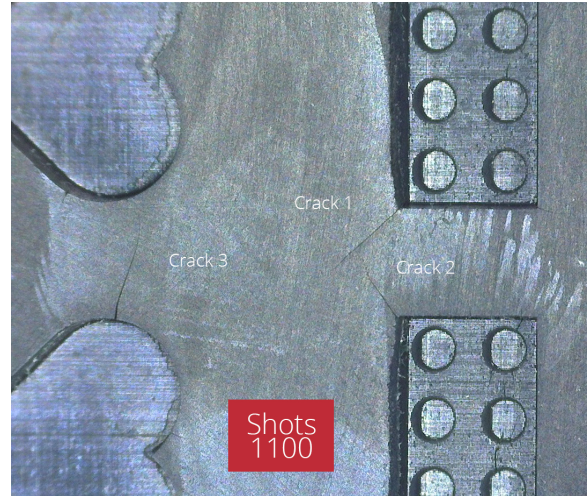
FIGURE 6. Cracks in the insert after shot 1100.

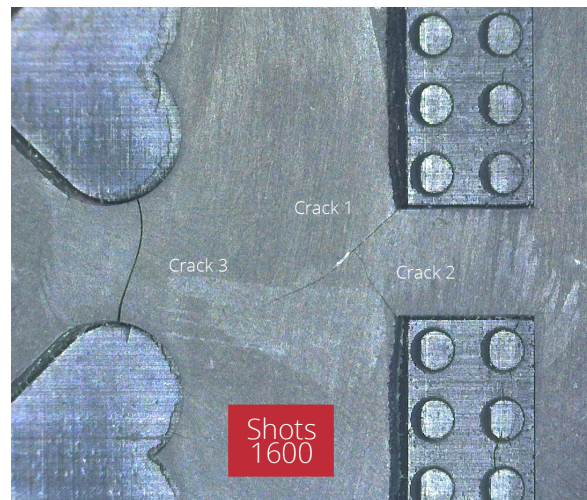
FIGURE 7. Cracks in the insert after shot 1600.

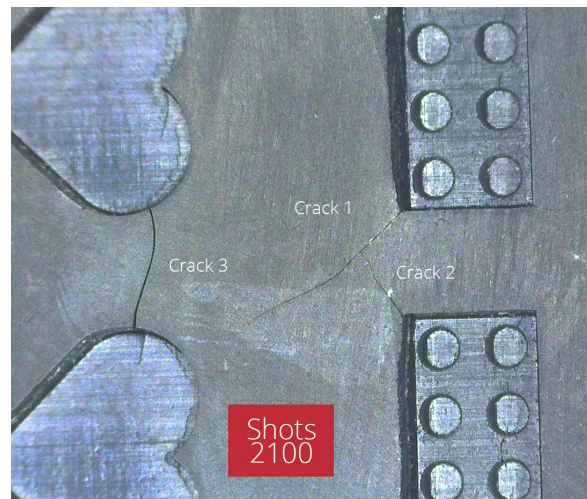
FIGURE 8. Cracks in the insert after shot 2100.

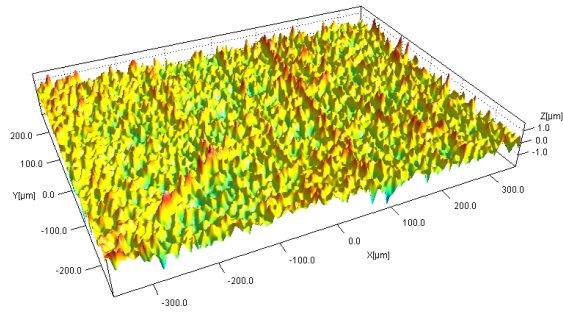
FIGURE 9. Graphical representation of the surface roughness after 10 shots showing the profile under a focal variation 3D-microscope in the middle of the insert.

A graphical representation of the surface of an insert in Figure 9 shows a central surface area with respect to height variations and roughness of the surface. The figure allows conclusions about scratches that were produced during the milling of the insert before the first shot.

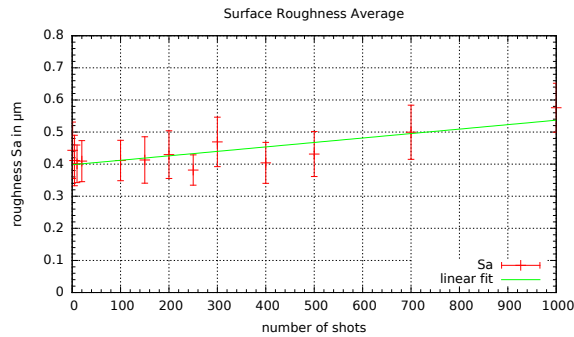
FIGURE 10. Averaged roughness propagation during the first 1000 shots neglecting bigger cracks in the surface.

Surface roughness despite bigger cracks evolves linearly according to the formula:

$$Sa(\text{shot}) = a + b \cdot \text{shot}$$

$$a = 0.398128 \pm 0.01219$$

$$b = 0.000138742 \pm 3.014 \times 10^{-5}$$

which allows the conclusion that the changes in the general surface roughness can be neglected. The average surface roughness was calculated over 7 inserts with respect to the first 1000 shots (see Figure 10).

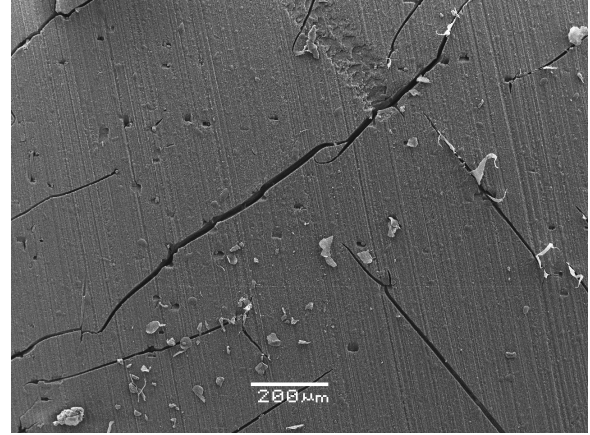
FIGURE 11. Surface cracks in the insert after 2658 shots under an SEM, the debris result from PE-LD stuck in the cracks

Cracks of the insert were reduced to surface cracks as shown in Figure 11 after 2658 shots with low propagation speed and gap size in the range of 1 to 5 μm. Most cracks originated from the edges in the surface of the insert as shown in Figure 12. Those were degrading in such a way that the edges became round as can be seen in Figure 13.

The cracks were reproduced in the molded part in the form of flashes for low gap sizes. At larger shot numbers, PE-LD got stuck in the gap as shown in Figure 14 as a detail of Figure 11 and therefore caused severe damage to the produced part. The insert was then characterized as destroyed.

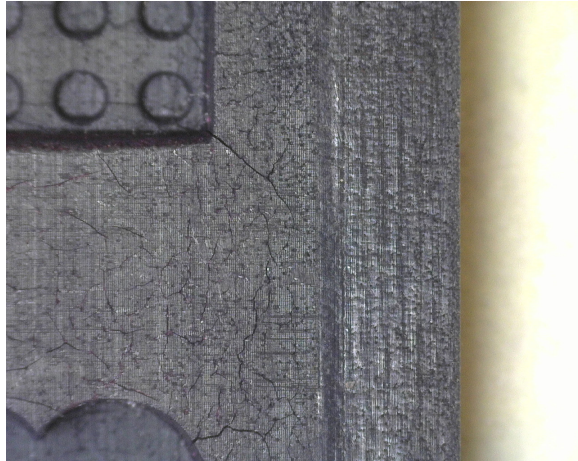
FIGURE 12. Insert surface after 2658 shots showing crack origin at edges as well as parts of the protected surface without cracks.

Figure 12 includes parts of the surface protected against thermal and mechanical strain. No cracks evolved in the protected part of the surface and no cracks originated at its border.

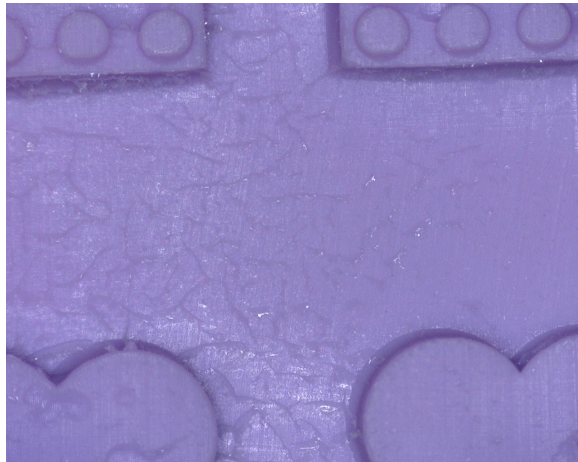
FIGURE 13. Part surface and rounded edges after 2658 shots.

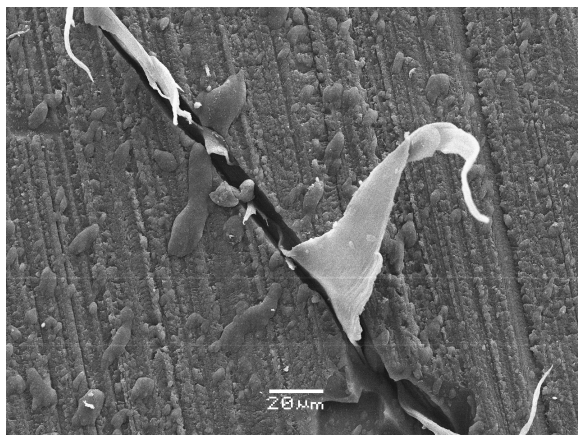
FIGURE 14. Detail of surface degradation with PE-LD material stuck in the crack.
